Hargrave

Inspection Ref: 2649468

Operational Inspection - 14-March-2025 - 10:48 Inspector Philip Smith

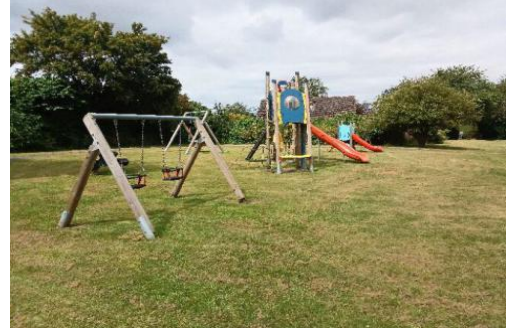
Item: Site General
Manufacturer: Owner/Operator
Surface Type: N/A
Item Part Number:
Item Quantity: 1

The grass mats are silted up and the soil is compacted; this may have an effect on the impact absorbing properties of the surface - Consider HIC testing impact absorbing properties to ensure the correct surface qualities are maintained for the equipment and replace as required

There are stress fractures in the tarmac surface - Monitor and repair if required

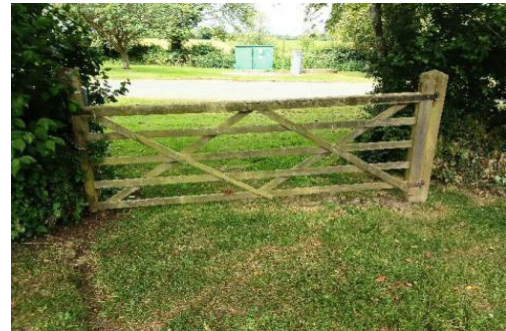
Item: Gate - Maintenance
Manufacturer: Not Identified
Surface Type: Grass
Item Quantity: 1

The item has been damaged - Monitor for any further deterioration and replace as required

There is an old post socket under the gate - Remove the concrete and reinstate to provide a uniform surface

There are projecting bolt thread(s) present - Remove excess thread length and deburr or provide cap

The surface has eroded and the foundations are exposed - Reinstate surrounding surfaces to cover the foundations

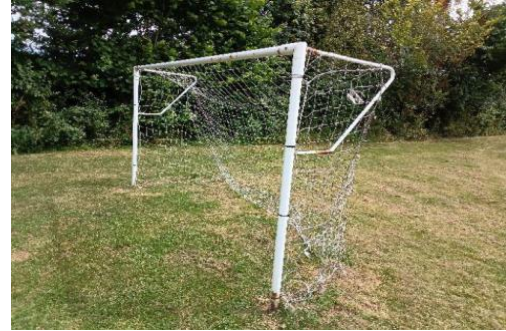
Item: Football Goal
Manufacturer: Not Identified
Surface Type: Grass
Item Quantity: 1

The paintwork on this item has been damaged or worn exposing the metal underneath which is rusting - Treat any rusting components and repaint

There is surface corrosion / rust present on the item - Consider treating the item

The item is slightly loose in its foundations - Monitor for any further deterioration and repair as required

The net is damaged - Replace the damaged net

A number of fixing(s) have worked loose - Secure all loose fixings

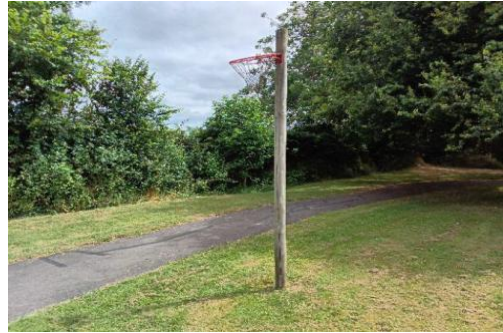
Item: Basketball Post
Manufacturer: Not Identified
Surface Type: Grass
Item Quantity: 1

There is some evidence of rot in the timber - Monitor for any further deterioration and replace as required

The timber has a number of splits/shakes or air cracks and this may affect the stability or allow water ingress which will accelerate the rotting process - Monitor to ensure the splits do not cross through fixing points of the structure and/or cause any instability

There is some strimmer / machinery damage apparent on the posts, this can penetrate the preservative applied to the timber and accelerate the rotting process - Monitor for any deterioration (rot) and replace as required

The item is slightly loose in its foundations - Monitor for any further deterioration and repair as required

There is some distortion damage to the hoop - Monitor for any further deterioration and repair as required

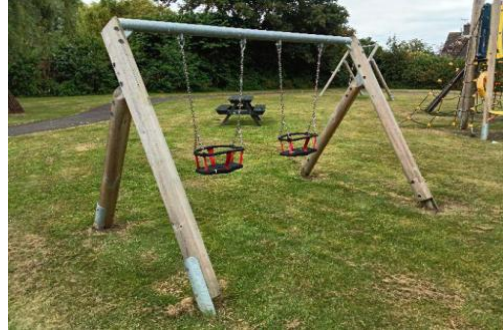
Item: 1 Bay 2 Seat (Cradle)
Manufacturer: Playdale Playgrounds Ltd
Surface Type: Grass Matrix Tiles
Item Quantity: 1

There is some strimmer / machinery damage apparent on the posts, this can penetrate the preservative applied to the timber and accelerate the rotting process - Monitor for any deterioration (rot) and replace as required

The seat has minor damage or wear - Monitor for any further deterioration and replace as required

The bushes are showing signs of wear - Monitor for any further deterioration and replace as required

There is some wear to the shackles - Monitor for any further deterioration and replace when 40% worn

There is some notable evidence of chain wear - Monitor for any further deterioration and replace when 40% worn

The seat surround has corroded - Replace seat

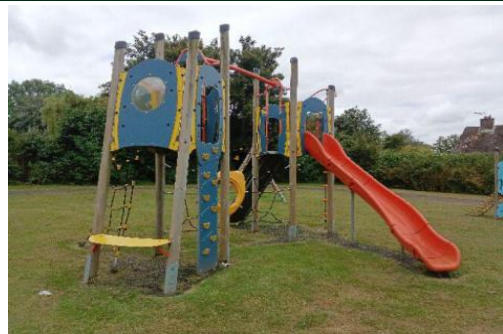
Item: Multi Play (Senior)
Manufacturer: Playdale Playgrounds Ltd
Surface Type: Grass Matrix Tiles
Item Quantity: 1

There are gaps opening in between the tiles - Monitor for any further deterioration and repair as required

A number of fixing(s) have worked loose - Secure all loose fixings

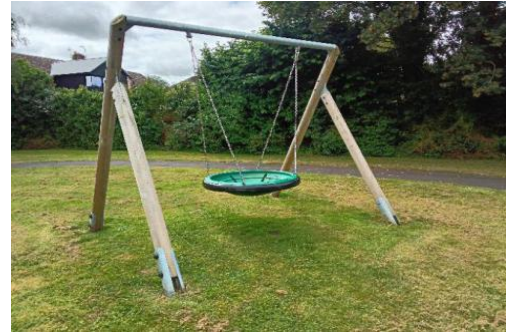
Item: Basket Swing - Type 1
Manufacturer: Playdale Playgrounds Ltd
Surface Type: Grass Matrix Tiles
Item Quantity: 1

There is/are bolt cap covers missing or damaged on the item - Replace missing or damaged bolt cap covers

The timber has a number of splits/shakes or air cracks and this may affect the stability or allow water ingress which will accelerate the rotting process - Monitor to ensure the splits do not cross through fixing points of the structure and/or cause any instability

There is some notable evidence of chain wear - Monitor for any further deterioration and replace when 40% worn

The fixings have corroded excessively - Replace all corroded fixings

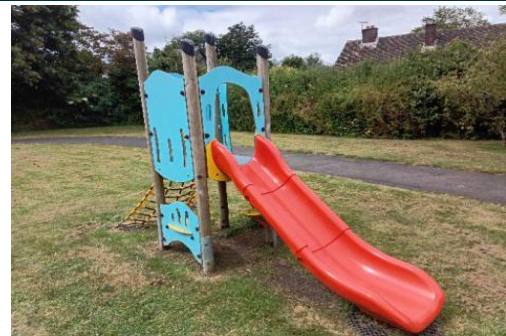
Item: Multi Play (Junior)
Manufacturer: Playdale Playgrounds Ltd
Surface Type: Grass Matrix Tiles
Item Quantity: 1

There is/are bolt cap covers missing or damaged on the item - Replace missing or damaged bolt cap covers

There are a number of cracks in the slide surface - Monitor for any further deterioration and repair as required

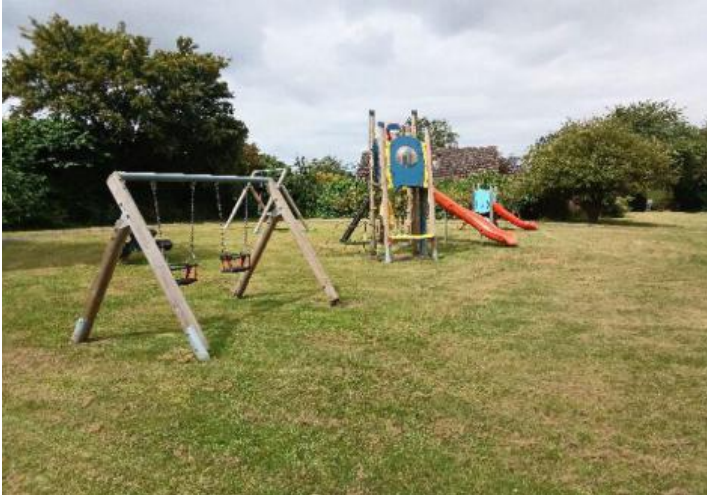
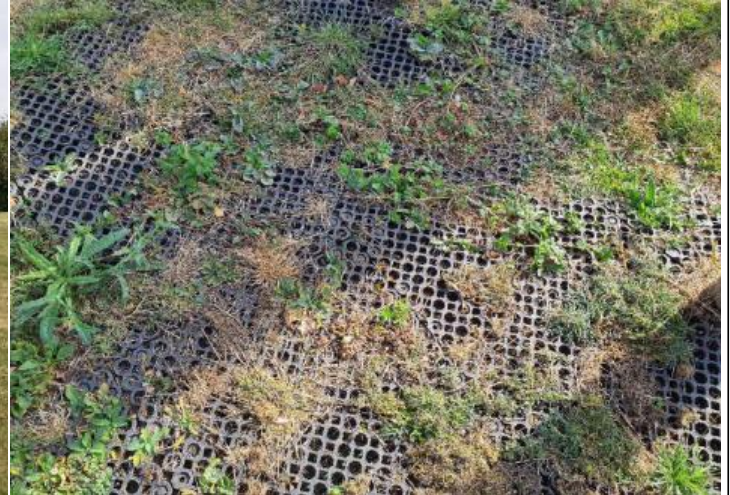
8 - Low Risk (Finding 1)

Finding: The grass mats are silted up and the soil is compacted; this may have an effect on the impact absorbing properties of the surface

Action: Consider HIC testing impact absorbing properties to ensure the correct surface qualities are maintained for the equipment and replace as required

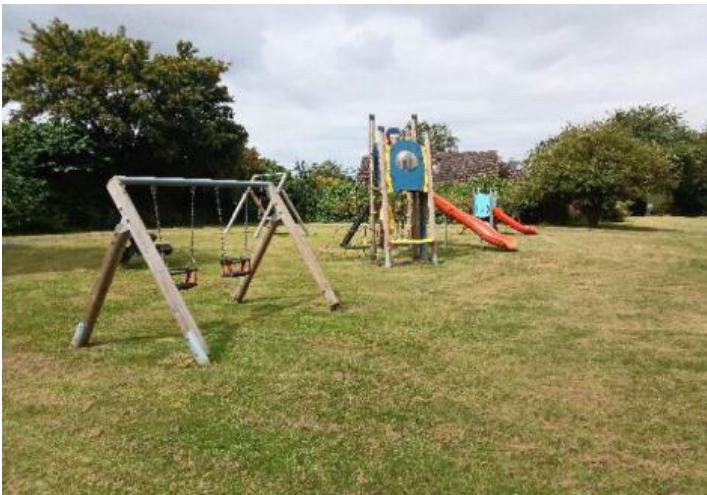
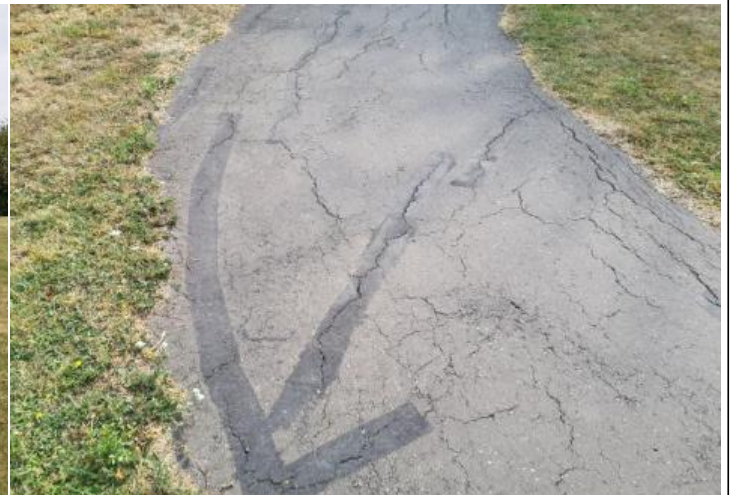
6 - Low Risk (Finding 2)

Finding: There are stress fractures in the tarmac surface

Action: Monitor and repair if required

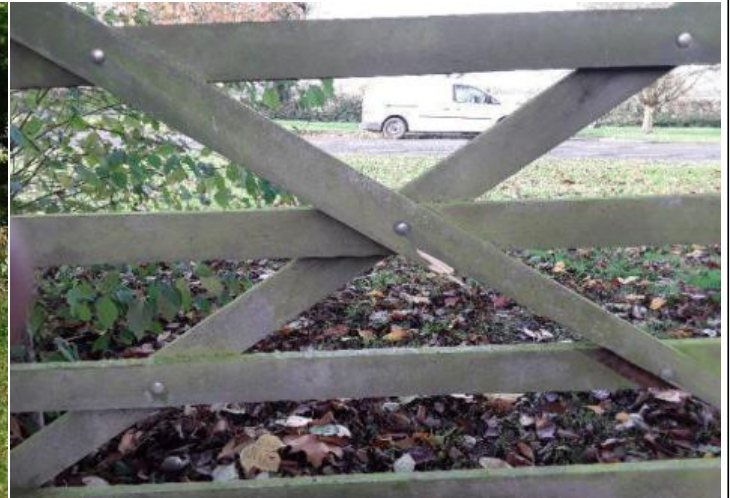
i 6 - Low Risk (Finding 1)

Finding: The item has been damaged

Action: Monitor for any further deterioration and replace as required

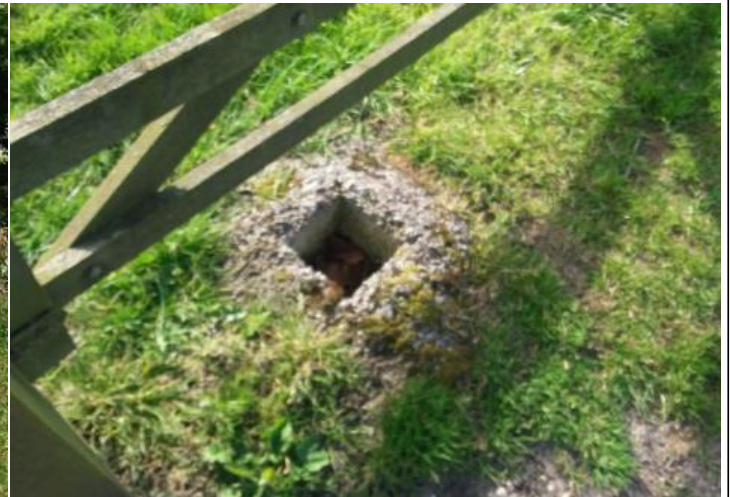
i 8 - Low Risk (Finding 2)

Finding: There is an old post socket under the gate

Action: Remove the concrete and reinstate to provide a uniform surface

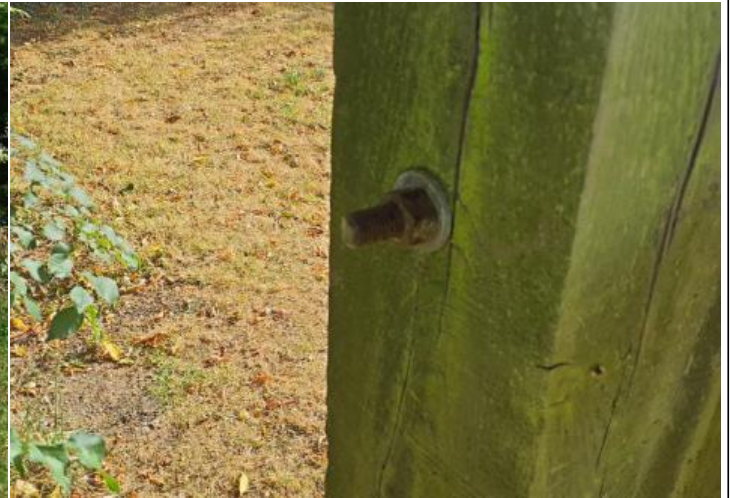
i 8 - Low Risk (Finding 3)

Finding: There are projecting bolt thread(s) present

Action: Remove excess thread length and deburr or provide cap

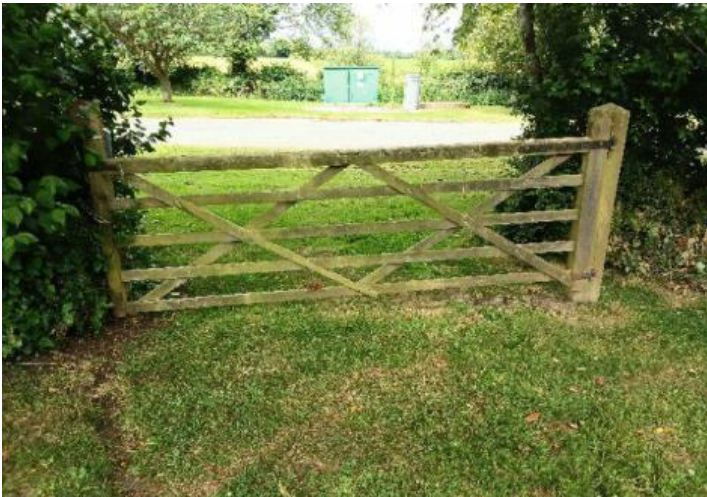
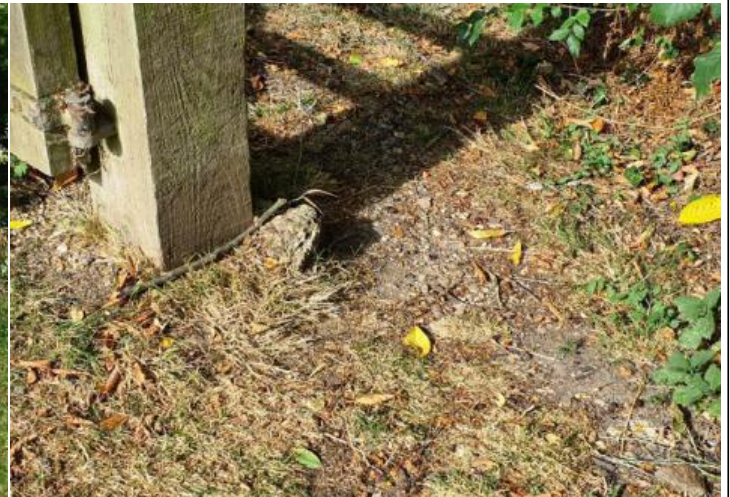
i 8 - Low Risk (Finding 4)

Finding: The surface has eroded and the foundations are exposed

Action: Reinstate surrounding surfaces to cover the foundations

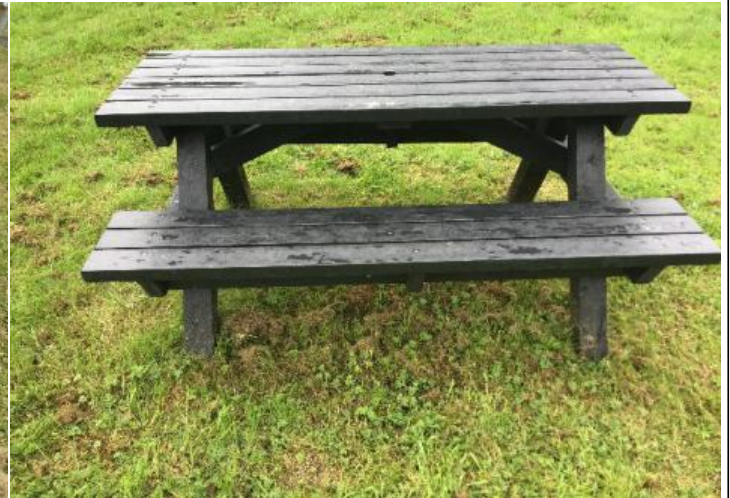
i 8 - Low Risk (Finding 1)

Finding: The bench/es is/are not securely fixed to the surface and there is some possibility of the item/s tipping or rolling over

Action: Secure to the ground

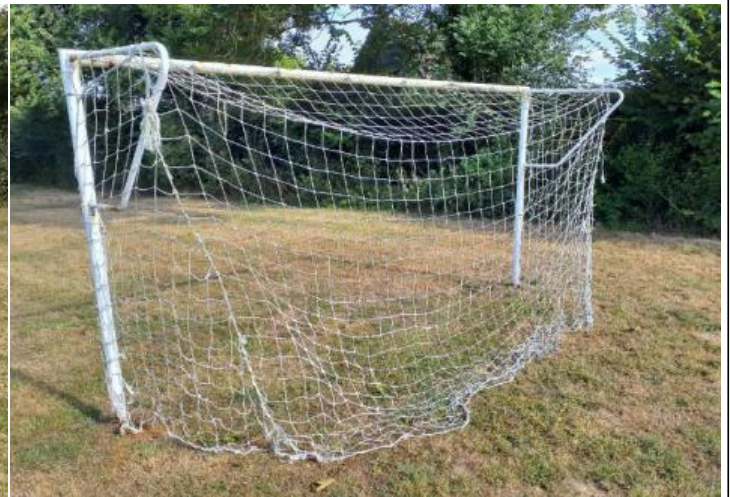
i 0 - Risk Assessment not Undertaken (Finding 1)

Finding: NB: We have undertaken a maintenance inspection only of the football goal(s); full load testing falls outside the scope of our inspection.

Action: Implement load testing as required

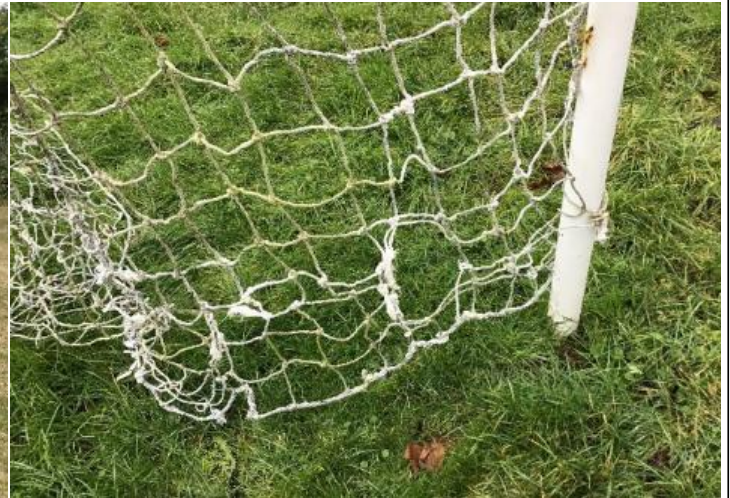
i 6 - Low Risk (Finding 2)

Finding: The net is damaged

Action: Replace the damaged net

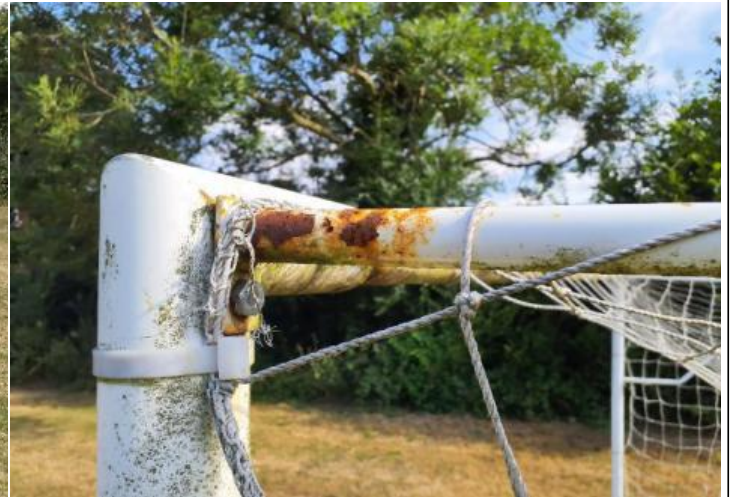
i 6 - Low Risk (Finding 3)

Finding: The paintwork on this item has been damaged or worn exposing the metal underneath which is rusting

Action: Treat any rusting components and repaint

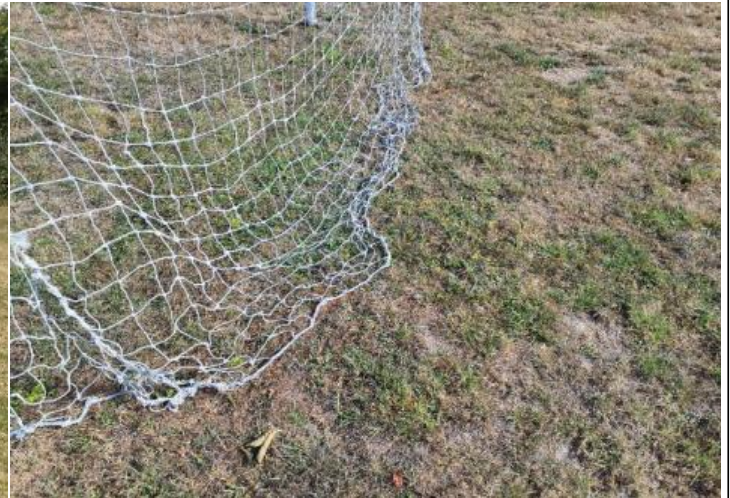
i 8 - Low Risk (Finding 4)

Finding: The net is not secured correctly

Action: Refer to the manufacturers specification and rectify

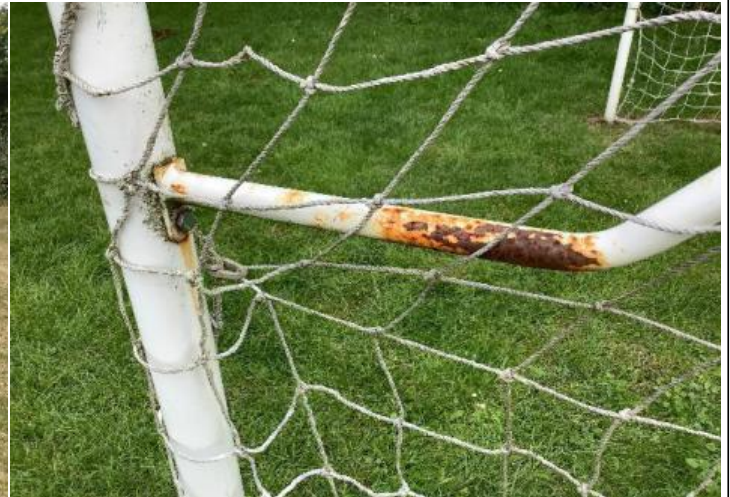
i 6 - Low Risk (Finding 5)

Finding: There is surface corrosion / rust present on the item

Action: Consider treating the item

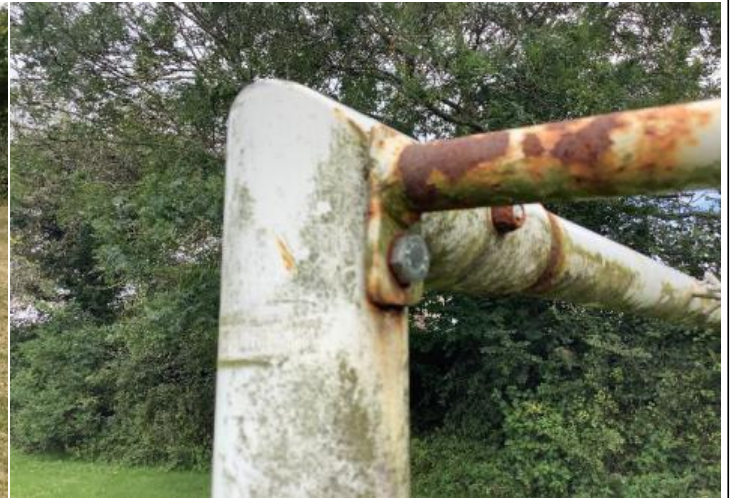
i 6 - Low Risk (Finding 6)

Finding: A number of fixing(s) have worked loose

Action: Secure all loose fixings

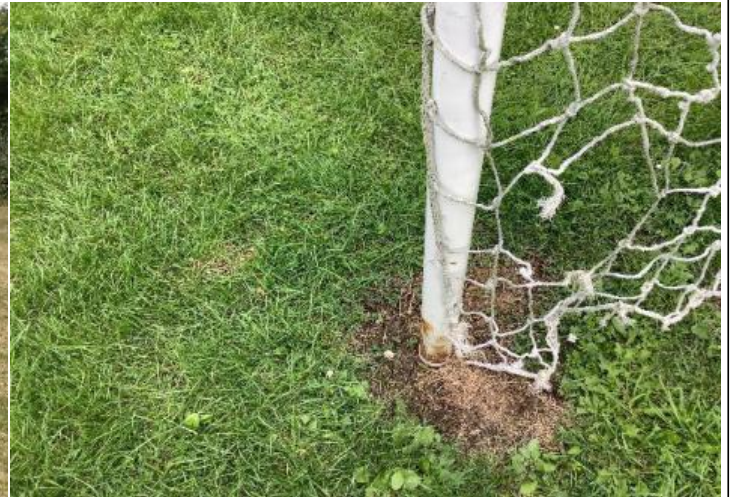
i 6 - Low Risk (Finding 7)

Finding: The item is slightly loose in its foundations

Action: Monitor for any further deterioration and repair as required

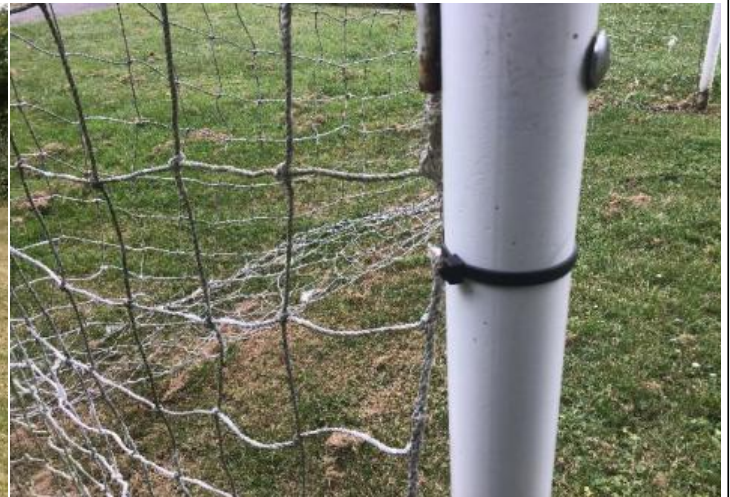
i 6 - Low Risk (Finding 9)

Finding: Cable ties have been used to secure the net and have been cut leaving sharp edges

Action: Remove cable ties

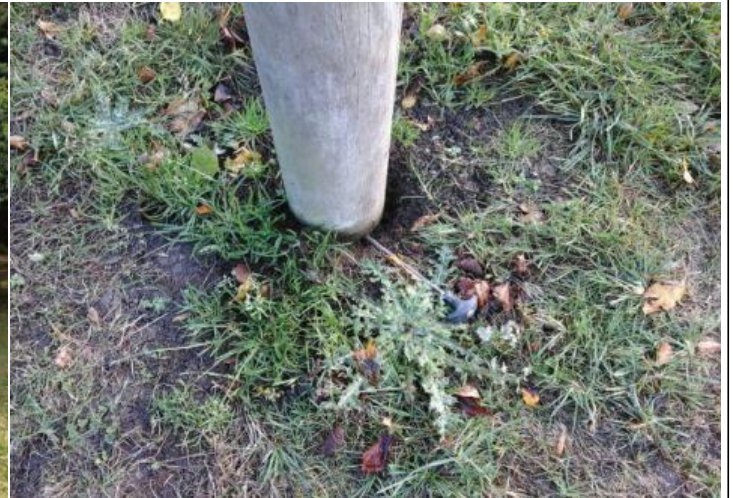
i 6 - Low Risk (Finding 1)

Finding: There is some evidence of rot in the timber

Action: Monitor for any further deterioration and replace as required

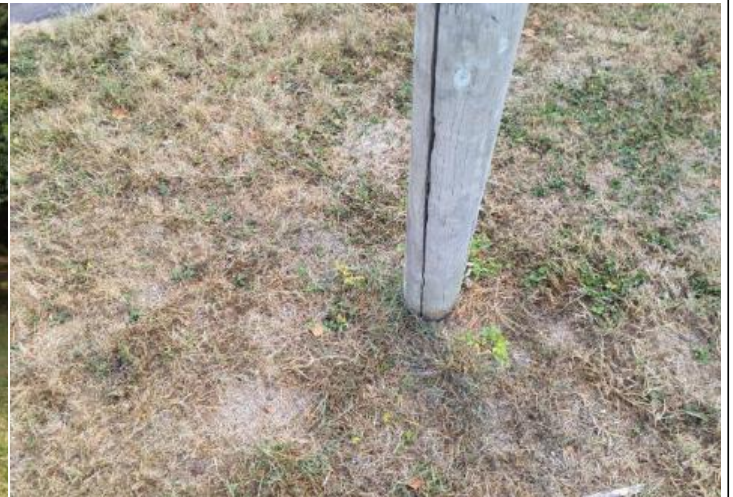
i 6 - Low Risk (Finding 2)

Finding: The timber has a number of splits/shakes or air cracks and this may affect the stability or allow water ingress which will accelerate the rotting process

Action: Monitor to ensure the splits do not cross through fixing points of the structure and/or cause any instability

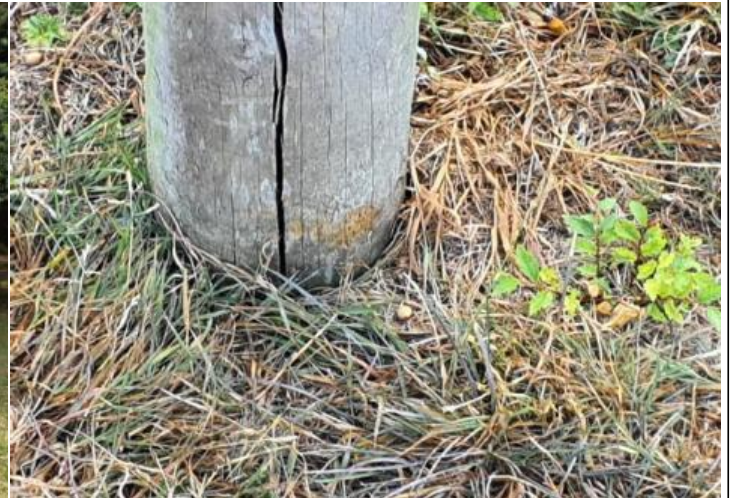
i 6 - Low Risk (Finding 3)

Finding: There is some strimmer / machinery damage apparent on the posts, this can penetrate the preservative applied to the timber and accelerate the rotting process

Action: Monitor for any deterioration (rot) and replace as required

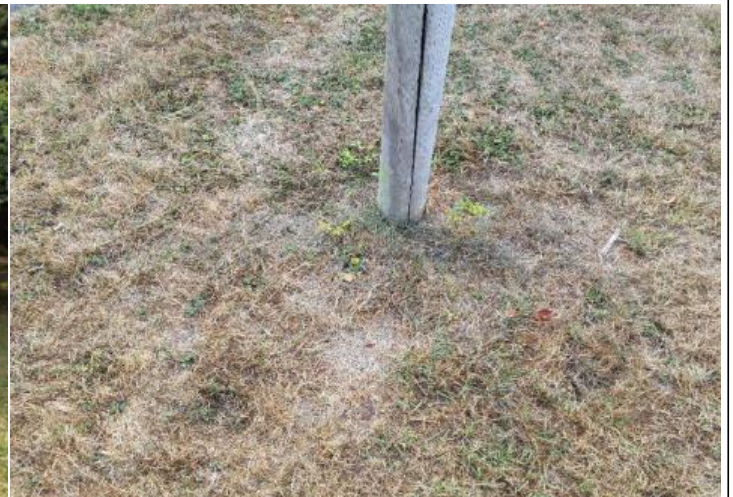
i 6 - Low Risk (Finding 4)

Finding: The item is slightly loose in its foundations

Action: Monitor for any further deterioration and repair as required

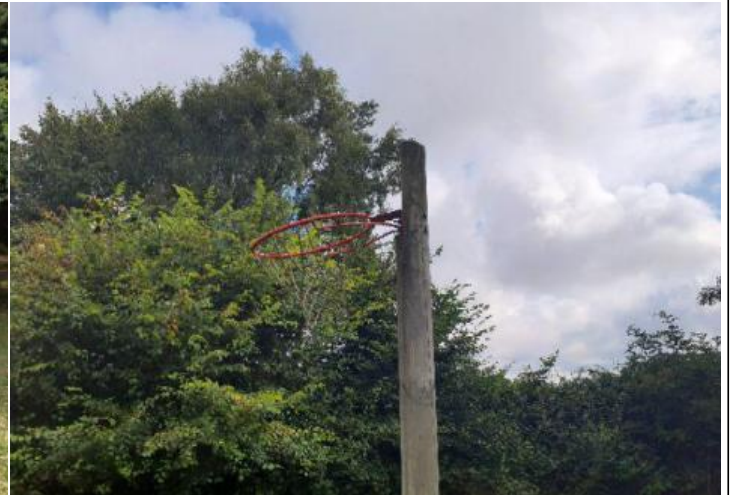
i 6 - Low Risk (Finding 5)

Finding: There is some distortion damage to the hoop

Action: Monitor for any further deterioration and repair as required

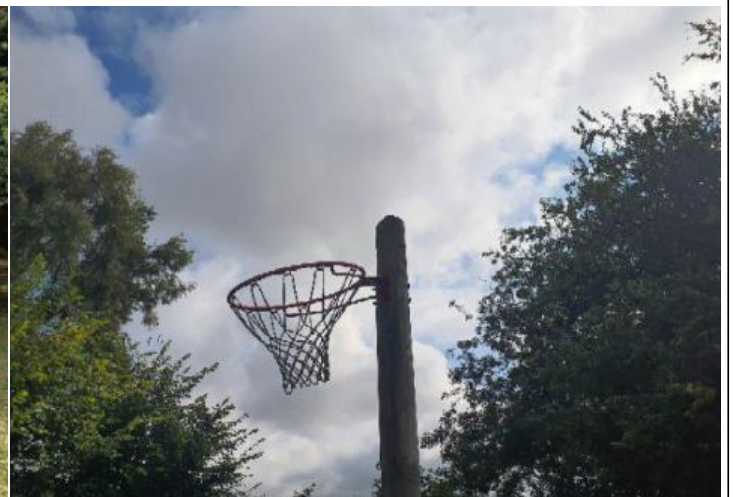
i 4 - Very Low Risk (Finding 6)

Finding: No backboard has been fitted

Action: Monitor and provide a backboard if required

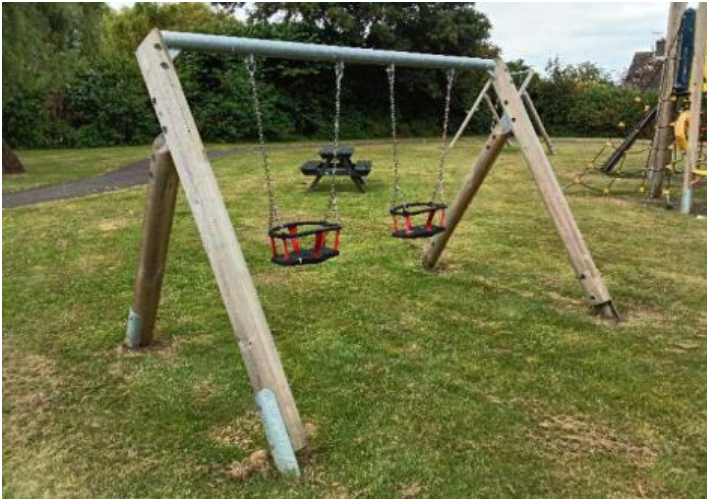
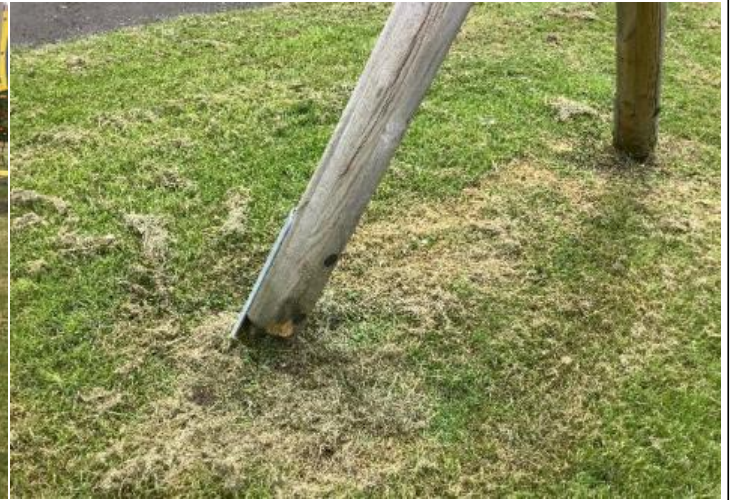
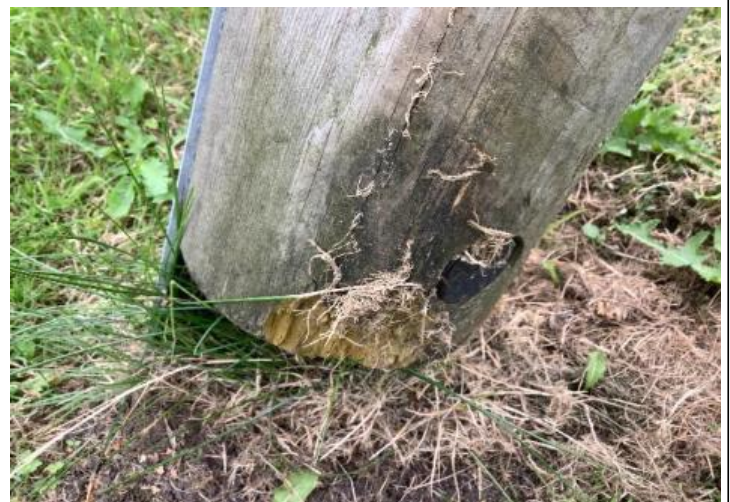
i 6 - Low Risk (Finding 1)

Finding: There is some strimmer / machinery damage apparent on the posts, this can penetrate the preservative applied to the timber and accelerate the rotting process

Action: Monitor for any deterioration (rot) and replace as required

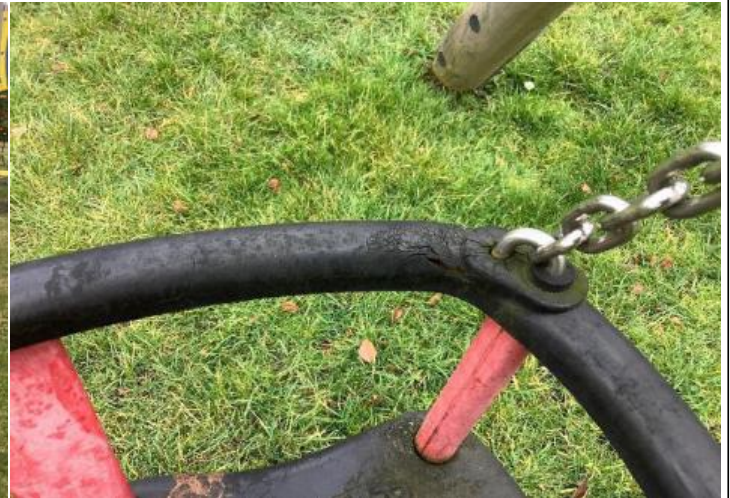
i 6 - Low Risk (Finding 2)

Finding: The seat has minor damage or wear

Action: Monitor for any further deterioration and replace as required

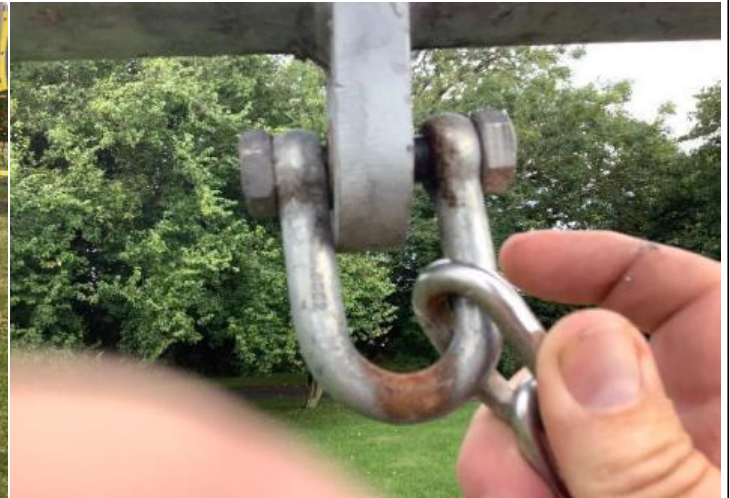
i 6 - Low Risk (Finding 4)

Finding: There is some wear to the shackles

Action: Monitor for any further deterioration and replace when 40% worn

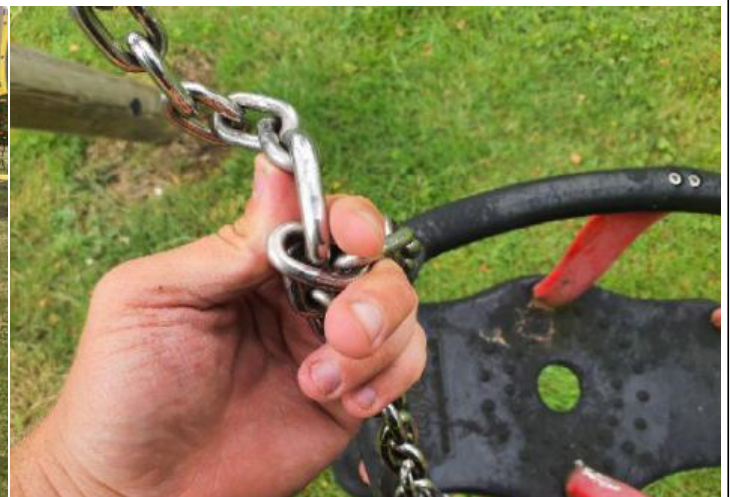
i 6 - Low Risk (Finding 5)

Finding: There is some notable evidence of chain wear

Action: Monitor for any further deterioration and replace when 40% worn

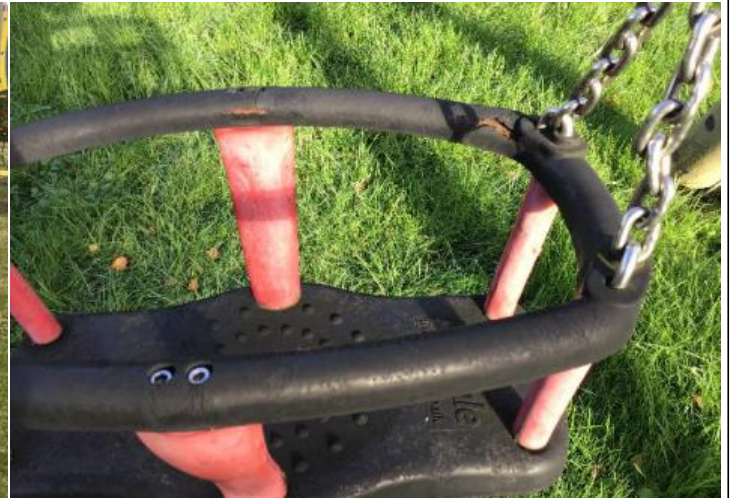
i 8 - Low Risk (Finding 6)

Finding: The seat surround has corroded

Action: Replace seat

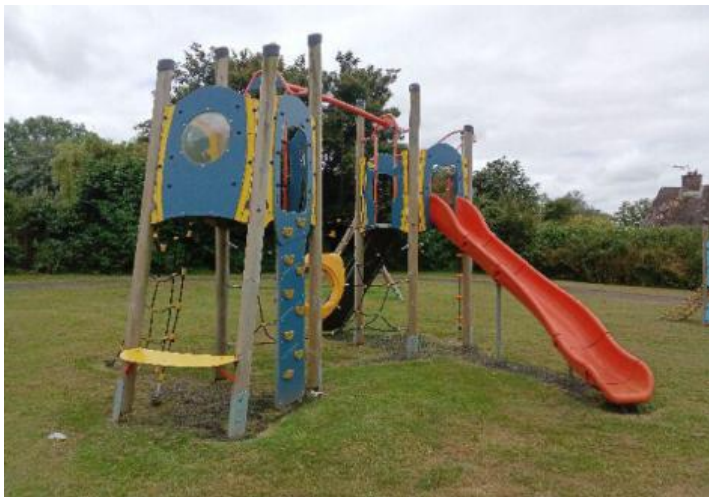
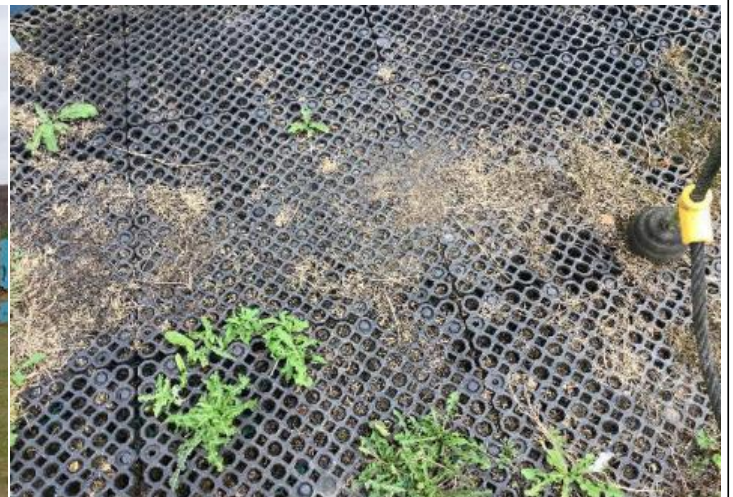
i 6 - Low Risk (Finding 1)

Finding: There are gaps opening in between the tiles

Action: Monitor for any further deterioration and repair as required

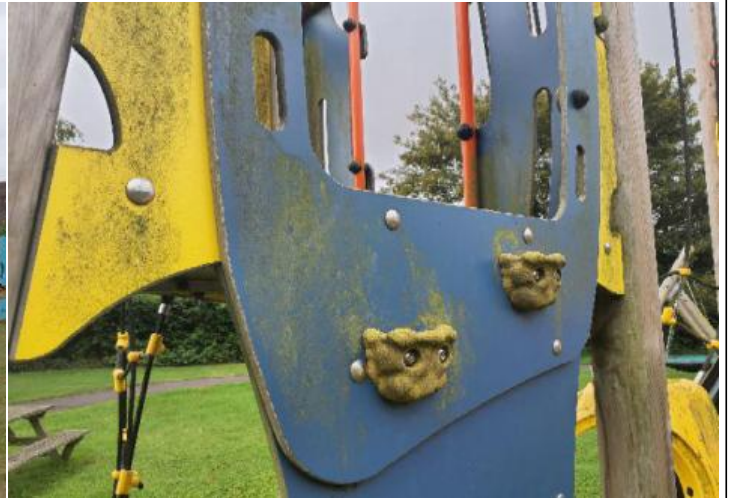
i 8 - Low Risk (Finding 2)

Finding: There is algae or moss on the surface of the equipment

Action: Clean and treat appropriately

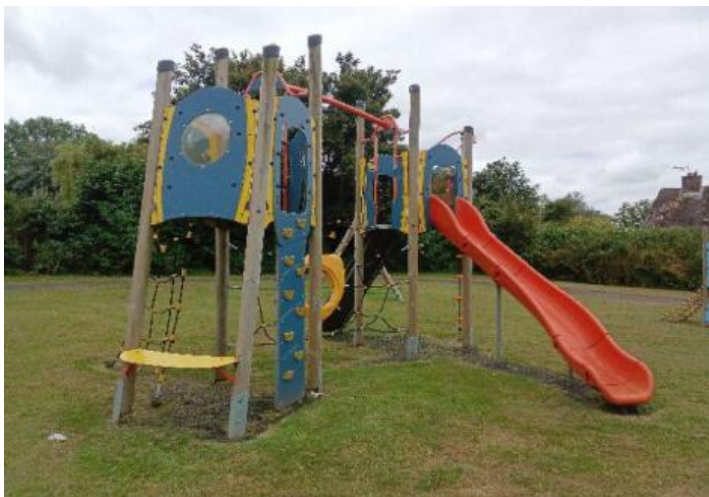
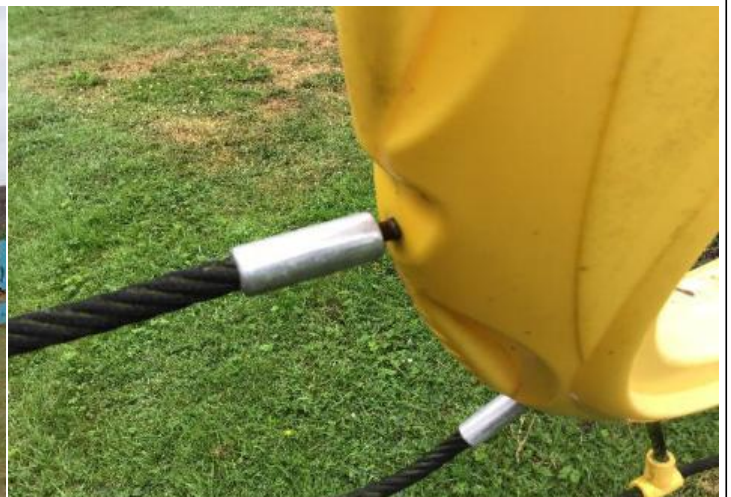
i 6 - Low Risk (Finding 3)

Finding: A number of fixing(s) have worked loose

Action: Secure all loose fixings

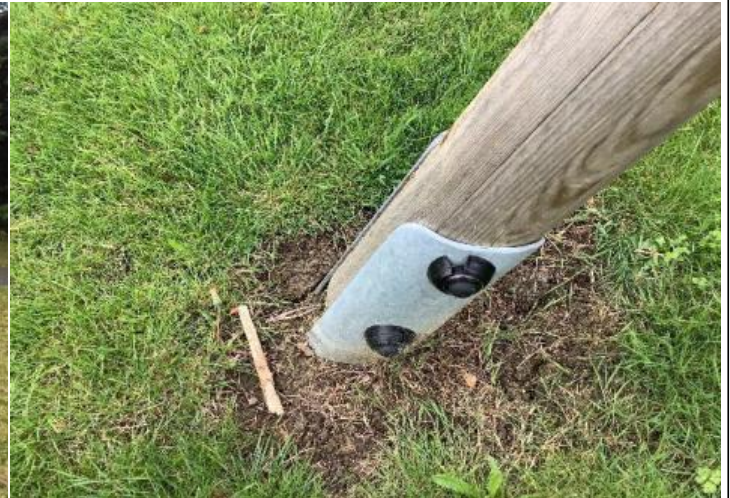
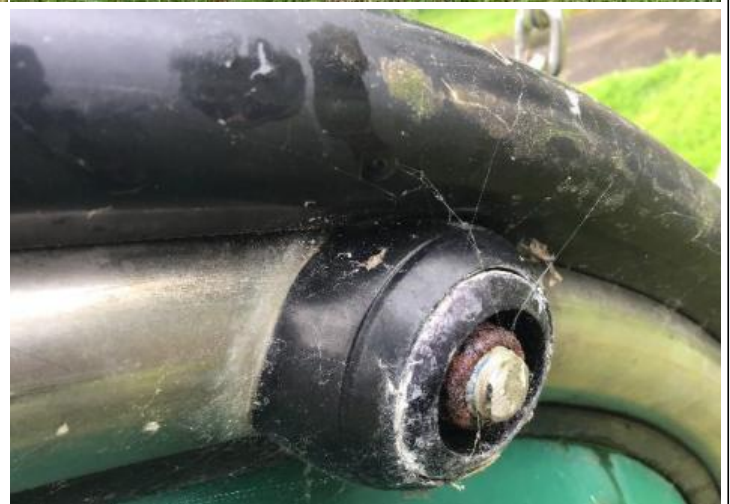
i 4 - Very Low Risk (Finding 1)

Finding: There is/are bolt cap covers missing or damaged on the item

Action: Replace missing or damaged bolt cap covers

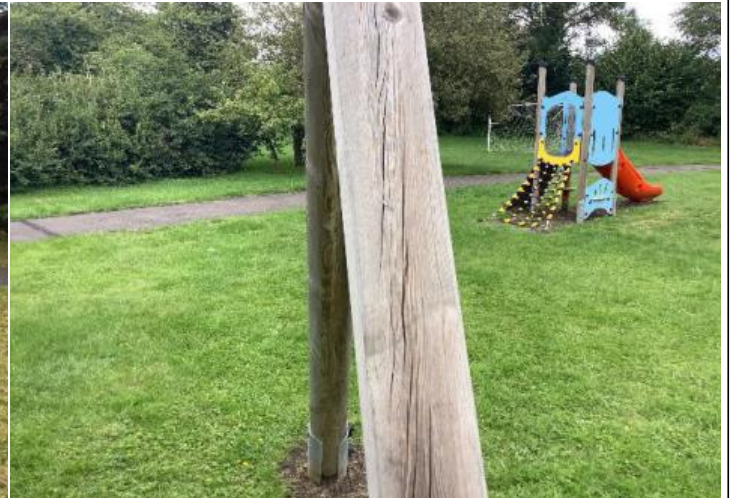
i 6 - Low Risk (Finding 2)

Finding: The timber has a number of splits/shakes or air cracks and this may affect the stability or allow water ingress which will accelerate the rotting process
Action: Monitor to ensure the splits do not cross through fixing points of the structure and/or cause any instability

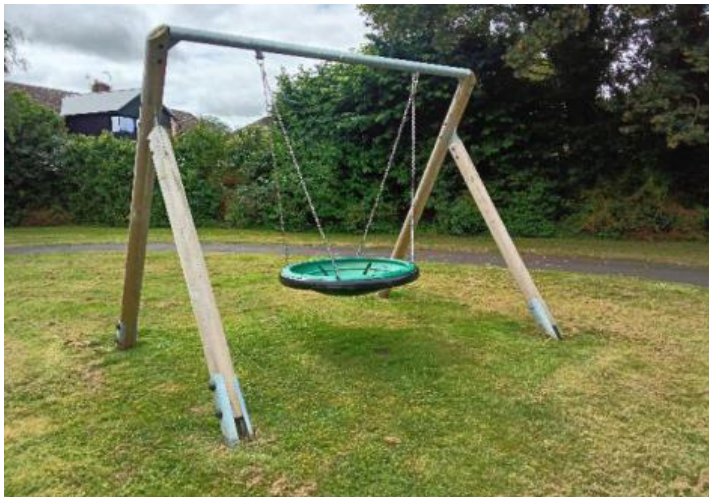
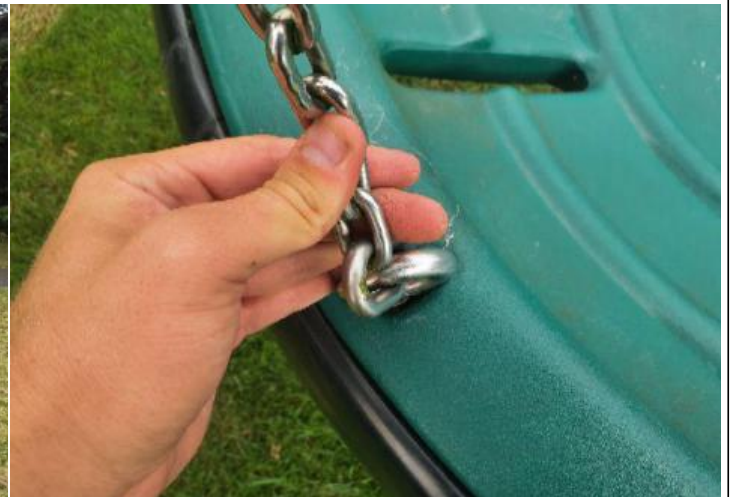
i 6 - Low Risk (Finding 3)

Finding: There is some notable evidence of chain wear
Action: Monitor for any further deterioration and replace when 40% worn

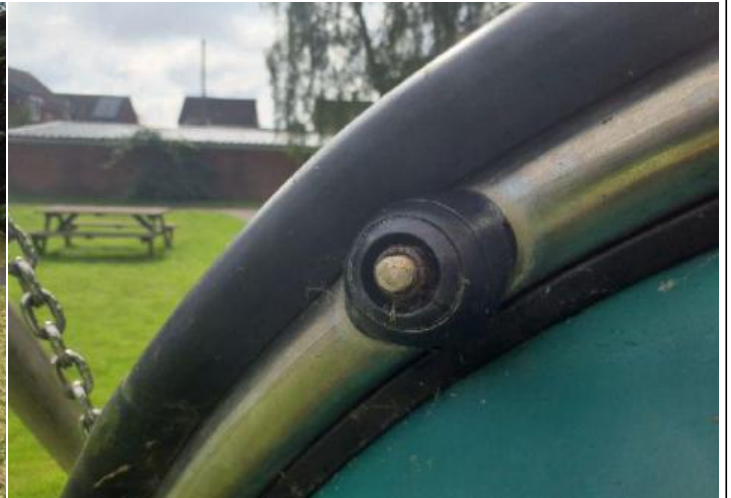
i 8 - Low Risk (Finding 4)

Finding: The fixings have corroded excessively

Action: Replace all corroded fixings

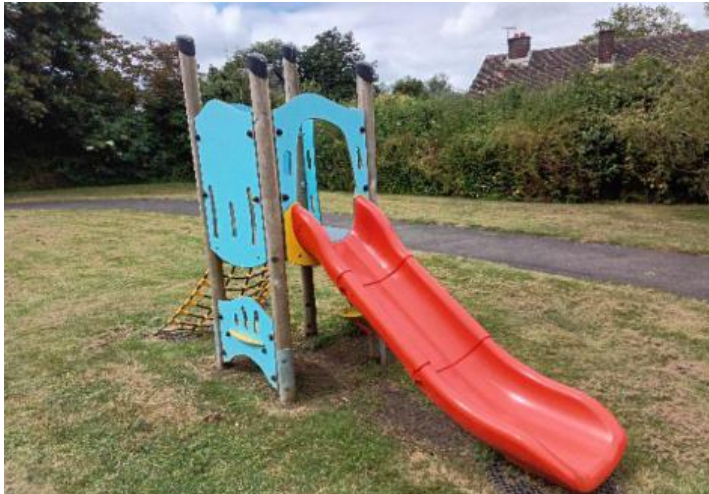
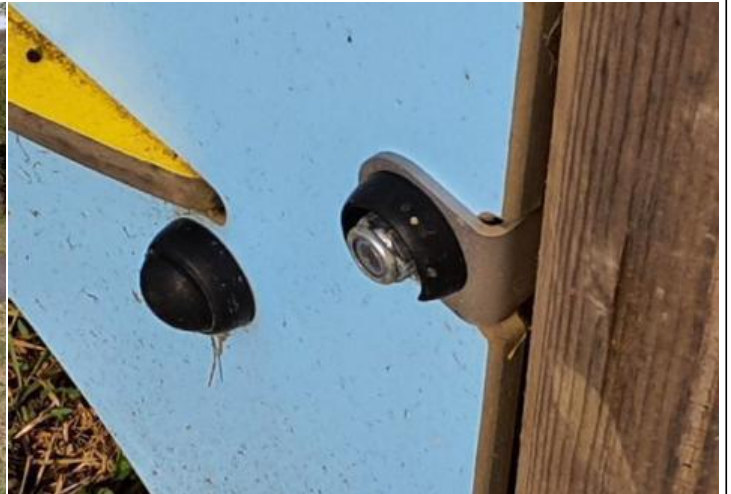
i 4 - Very Low Risk (Finding 1)

Finding: There is/are bolt cap covers missing or damaged on the item

Action: Replace missing or damaged bolt cap covers

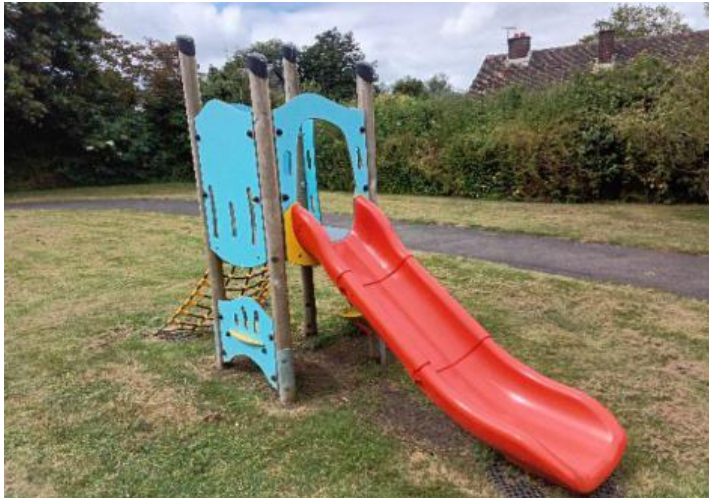
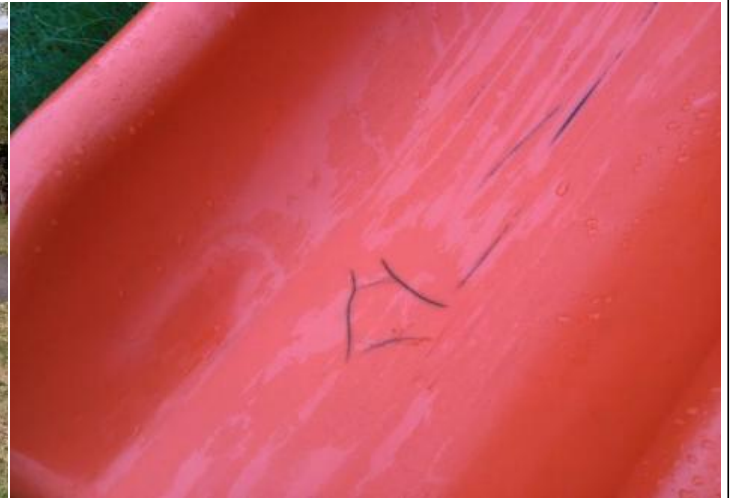
i 4 - Very Low Risk (Finding 2)

Finding: There are a number of cracks in the slide surface

Action: Monitor for any further deterioration and repair as required

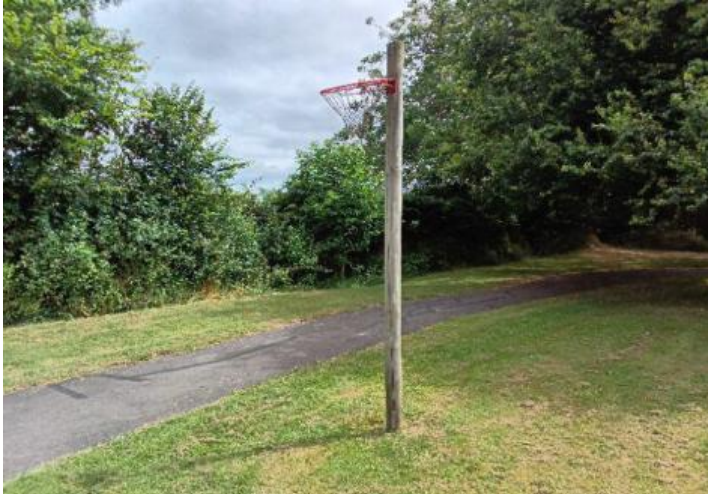
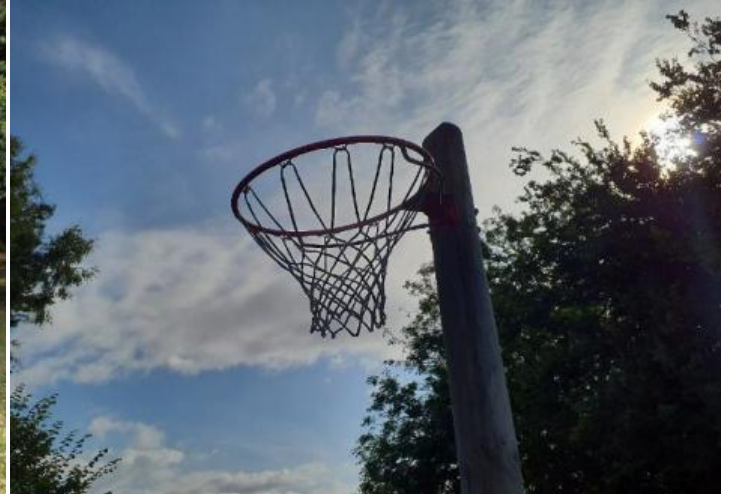
Item: Multi Use Games Area - Basketball Post
Manufacturer: Not Identified

Finding: No backboard has been fitted

Action: Monitor and provide a backboard if required
